## **Draft Report**

## Fish Tissue Dioxin Investigation for Dugdemona River (Subsegment #081401)

### **PARSONS**

March 2002

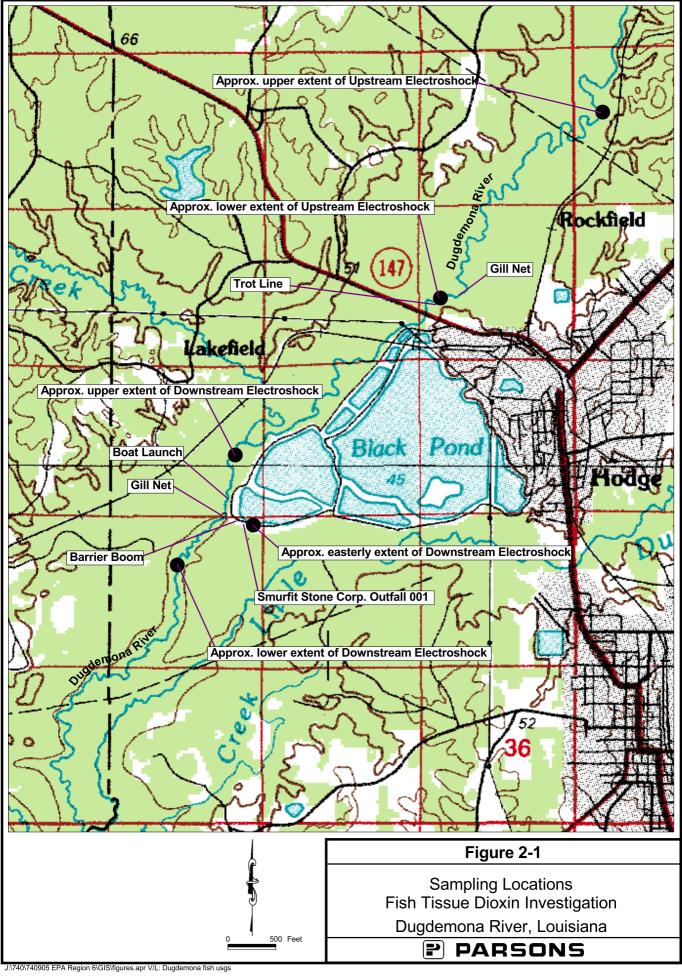
- Figure 2-1 shows sampling locations and other important features along this stretch of the Dugdemona River.
- Table 3-1 details information on the fish collected for the investigation. Table 3-1 also describes the compositing scheme for each sample and any anomalies with the samples.
  - Table 3-2 shows the dioxin analysis results for the fish and effluent samples.
- Table 3-3 shows dioxin toxicity equivalent (TEQs) on only the samples and analytes with analytical detections.

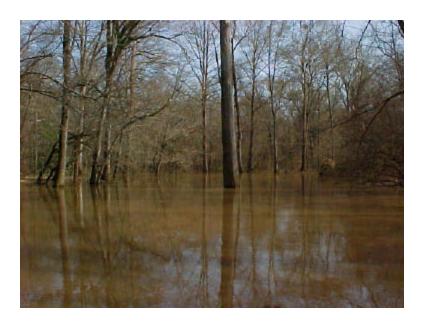
PHOTO 1: DUGDEMONA RIVER UPSTREAM SAMPLING LOCATION, UPSTREAM OF HIGHWAY 147. TYPICAL CROSS SECTION WITH TURBID WATER FOLLOWING RAINSTORM. FEBRUARY 2002

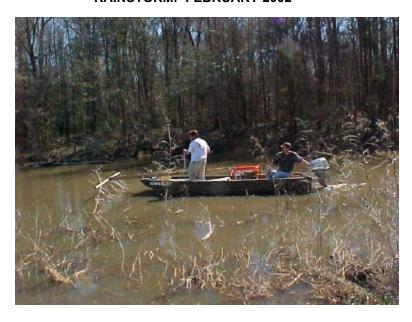
PHOTO 2: DUGDEMONA RIVER, CANAL FROM SMURFIT STONE CONTAINER CORPORATION OUTFALL TO THE RIVER. FISH COLLECTION BY ELECTROSHOCKING. FEBRUARY 2002

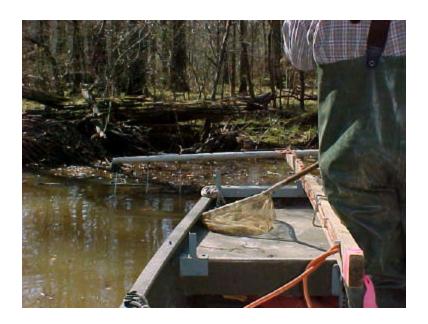
PHOTO 3: DUGDEMONA RIVER, UPSTREAM SAMPLING LOCATION, FISH COLLECTION USING ELECTROSHOCKING, SHOCKING IN DEBRIS PILES ALONG SHORELINE. FEBRUARY 2002

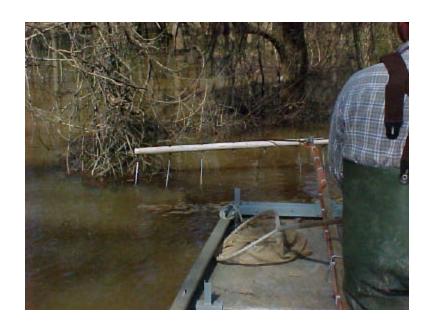
PHOTO 4: DUGDEMONA RIVER, UPSTREAM LOCATION, FISH COLLECTION USING ELECTROSHOCKING IN OVERHANGING DEBRIS. FEBRUARY 2002

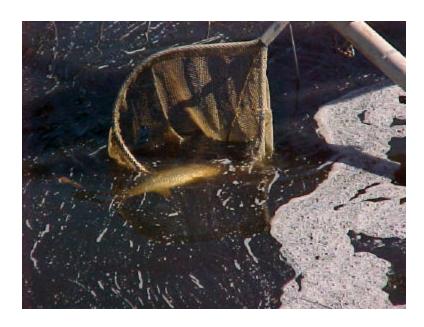
PHOTO 5: DUGDEMONA RIVER, ON CANAL AT DISCHARGE OUTFALL FROM SMURFIT STONE CONTAINER CORPORATION. COLLECTION OF CARP WITH NET AFTER ELECTROSHOCKING. FEBRUARY 2002

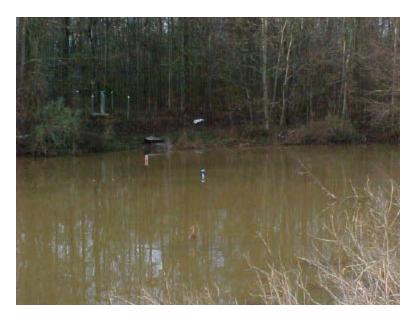
PHOTO 6: DUGDEMONA RIVER, DOWNSTREAM LOCATION, CANAL FROM OUTFALL TO RIVER, FLOATS FOR GILL NET WHICH IS SET ACROSS THE CHANNEL, EXTRA GILL NET ON FAR SHORE IN TUB. FEBRUARY 2002

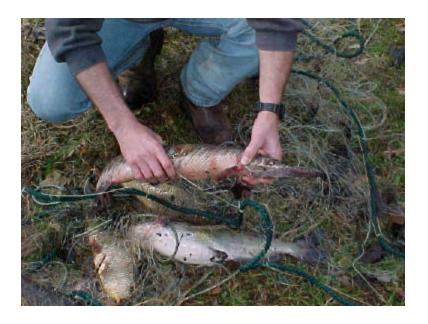
PHOTO 7: DUGDEMONA RIVER, REMOVING GAR FROM GILL NET AT DOWNSTREAM LOCATION. CATFISH AND CARP IN NET BELOW. FEBRUARY 2002

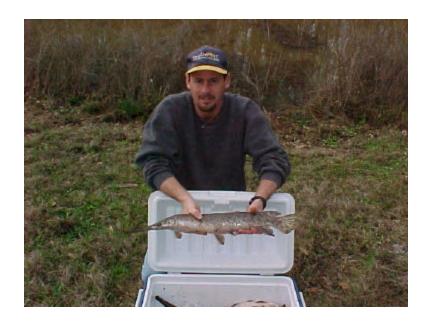
PHOTO 8: DUGDEMONA RIVER, DOWNSTREAM LOCATION, SPOTTED GAR COLLECTED IN GILL NET, GOING INTO COOLER ON ICE. FEBRUARY 2002
